## **Appendix A**

### **Photograph Log**

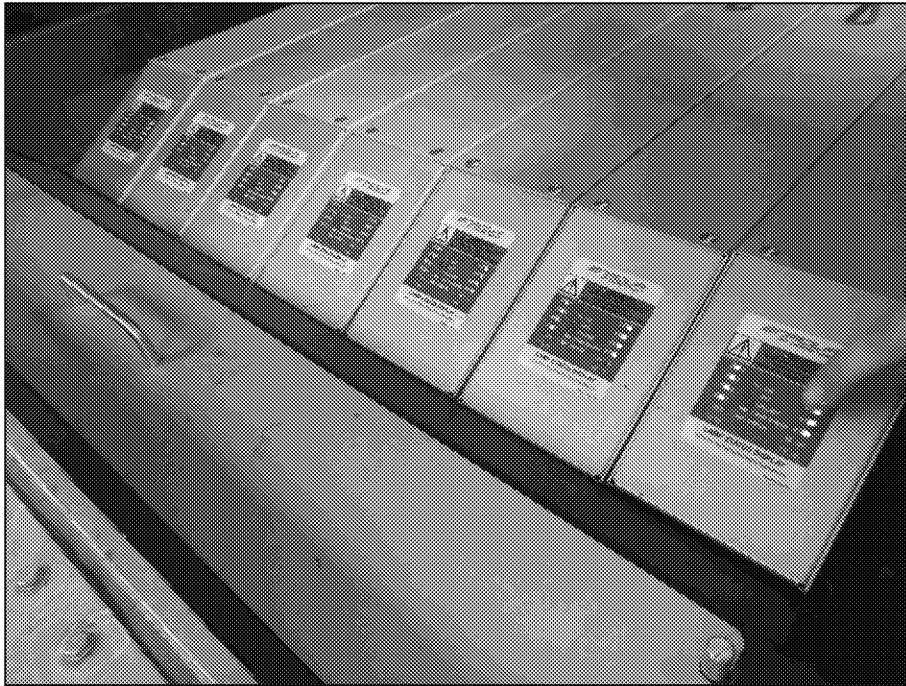
**Photograph 38.** View the UV light banks. Note that many of the lamp indicators were red, yellow, or flashing, indicating potential issues.

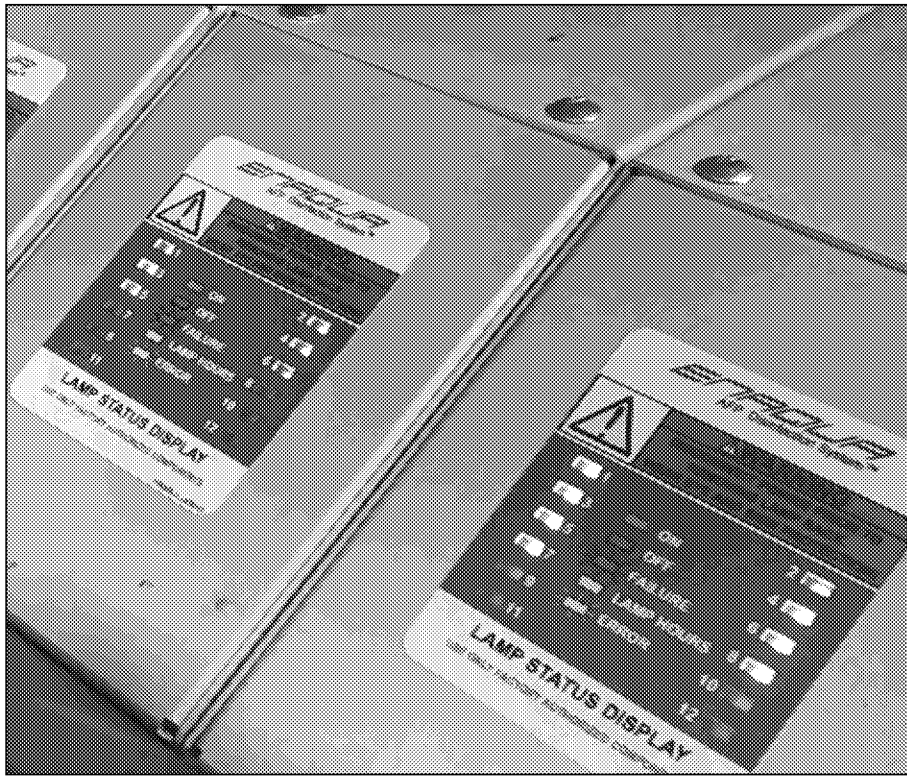
**Photograph 39.** View of UV lamp status indicators.

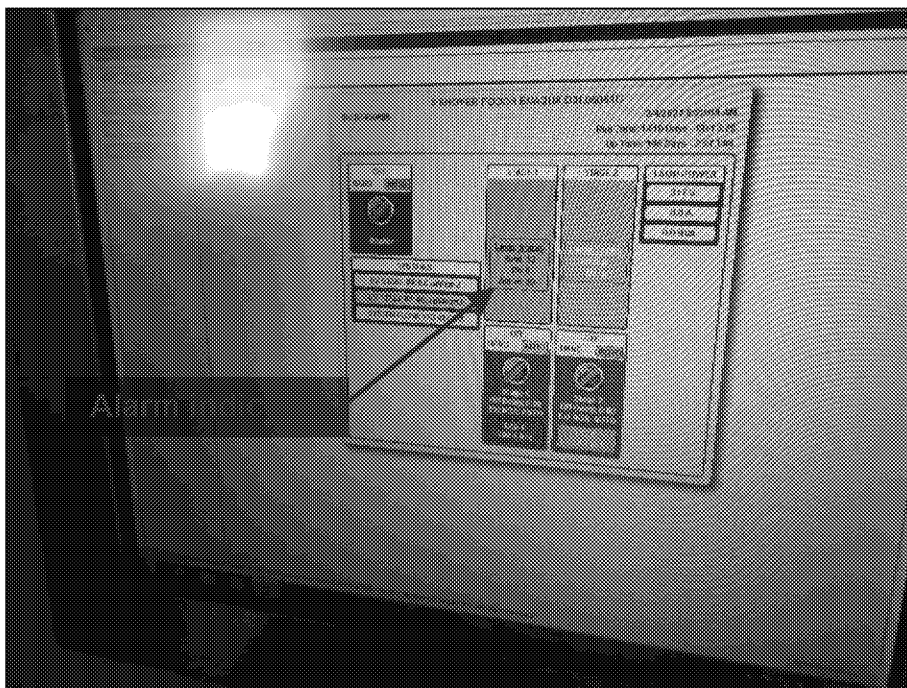
**Photograph 40.** View of the UV system interface showing 29 alarms for the stage 1 lamps.

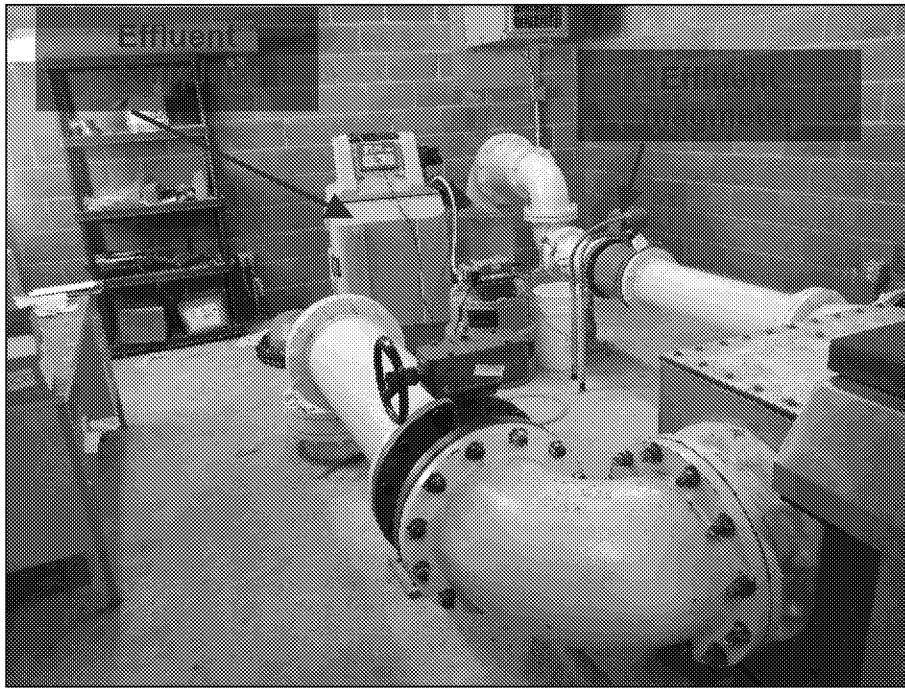
**Photograph 41.** View of the effluent sampler and magmeter, located in the UV building.

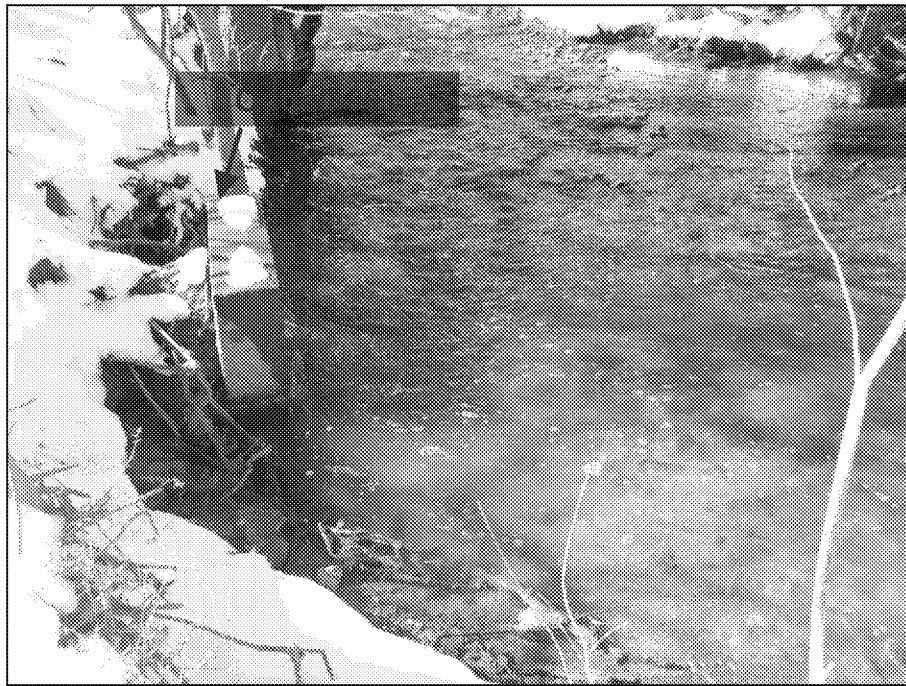
**Photograph 42.** View of the Outfall 001 discharge to Oil Creek. Note the creek was cloudy and turbid at the point of discharge and sphaerotilus bacterial growth was observed in the vicinity.
